Understanding and control of the effect of
potential induced degradation in p-type crystalline
silicon solar cells

NGUYEN CHUNG DONG

Division of Materials Science

Nara Institute of Science and Technology

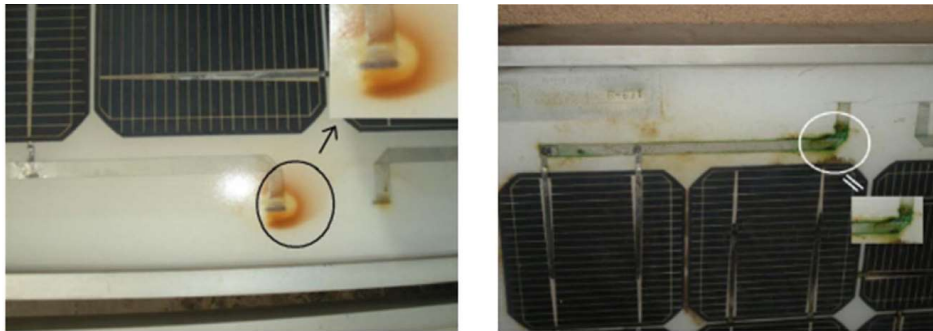
Figure 1. 3. Corrosion of metallic contact [11].

Corrosion is caused by moisture ingress to the module edge of the sheet material, leading to an increase of the electrical conductivity of the material and leakage currents. The corrosion at the metal frame causes deterioration of the solar modules, as shown in Figure 1. 3. Therein, the dislocation of the metal structure also induces adverse problems such as electrical hazards and corrosion. Kemp showed that the moisture in the solar module is correlated with the rate of degradation, especially in damp-heat geographic locations [8]. Also, Wohlgemuth and Kurtz found out that corrosion appeared after 1000 h of exposure of PV module under 85°C and 85% of relative humidity [9]. Carlson et al. demonstrated that the sodium contained in the glass is reactive with moisture, causing the corrosion of solar module edges [10]. The ingress of the moisture into the solar modules remains significant during their lifetime due to the relatively fast water diffusion in the EVA layer, leading to more rapid and considerable corrosion

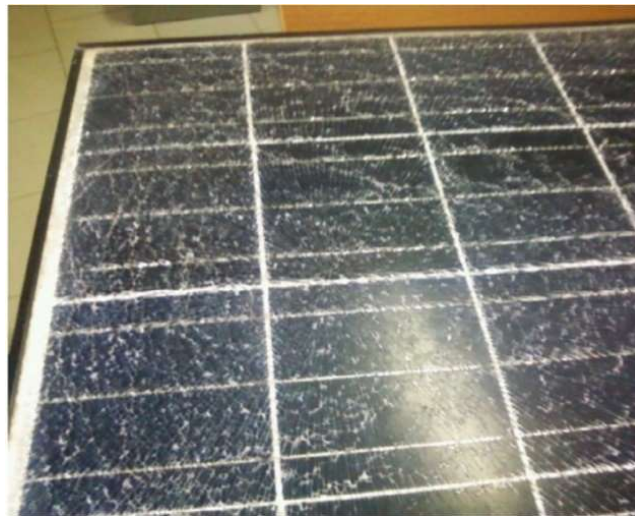
Figure 1. 5. A solar module with a broken glass [13].

One of the significant adverse degradation factors for solar modules is glass breakage, which commonly occurs in several cases such as installation, maintenance, and the transportation of modules on the installation sites. For example, a crystalline solar module was broken during operation for five years, as shown in Figure 1. 5. The performance degradation of solar modules caused by the breakage becomes more significant under damp-heat conditions due to moisture ingress. Other degradation types, such as corrosion, discoloration, and delamination, also may result in the breakages of solar modules [15]. To reduce the fabrication costs of solar cells and enhance the solar cell performance, the thickness and the surface of cells decreased from 300 μm to 200 μm to even less than 100 μm while the cell size increased to 210 mm \times 210 mm. Therefore, solar cells become more fragile and sensitive to breakages.

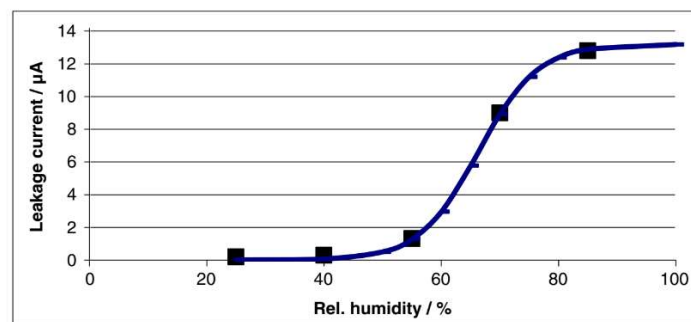
Figure 1. 12. Leakage current as a function of the relative humidity at 85 °C at 300 V negative bias [46].

sigmoidal growth function of the leakage current versus relative humidity was modeled by Hoffmann et al. [46], as shown in Figure 1. 12.

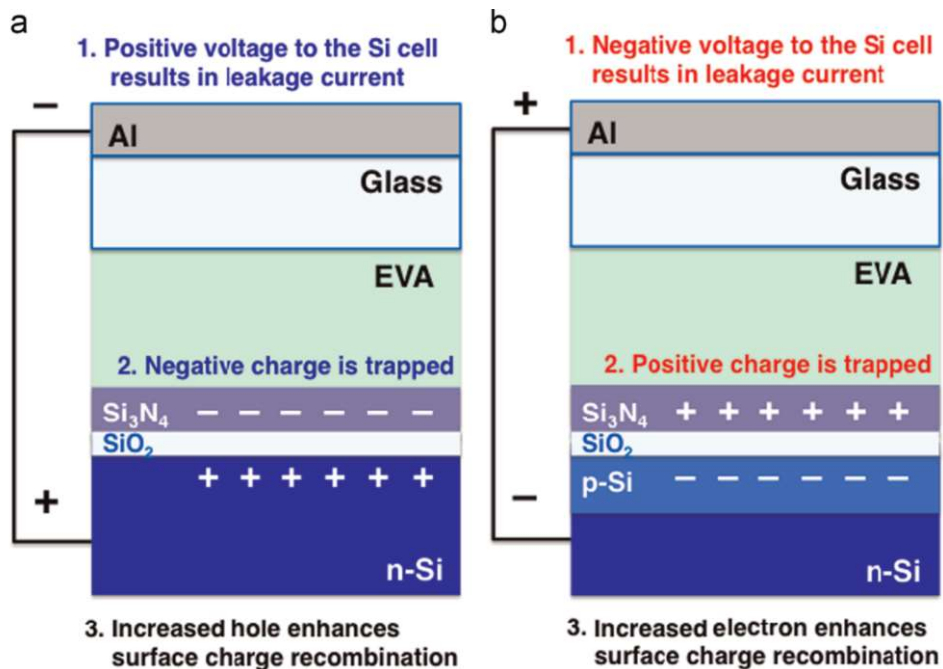
Figure 1. 18. The schematic diagram for the proposed PID mechanism in n-type c-Si solar modules: (a) n-type high-efficiency back-contact c-Si cells [42] and (b) a n-type high-efficiency front-junction c-Si cells [72].

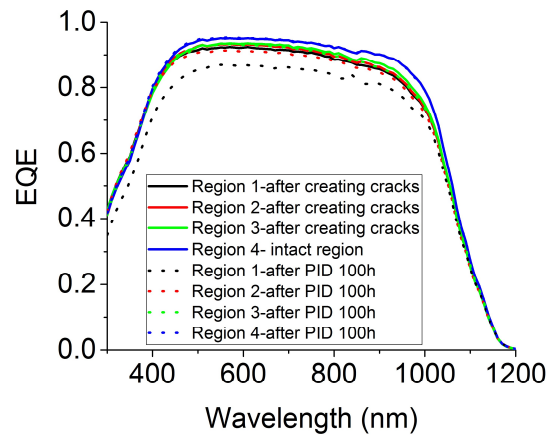
Figure 2. 9. EQE of 4 regions of the solar cell marked in Figure 2. 6.

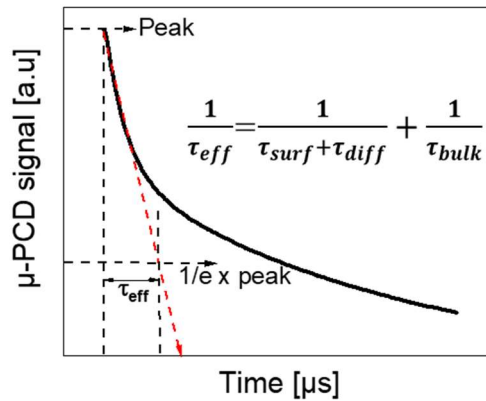
Figure 3. 4. An estimated effective lifetime based on the μ -PCD signal curve.

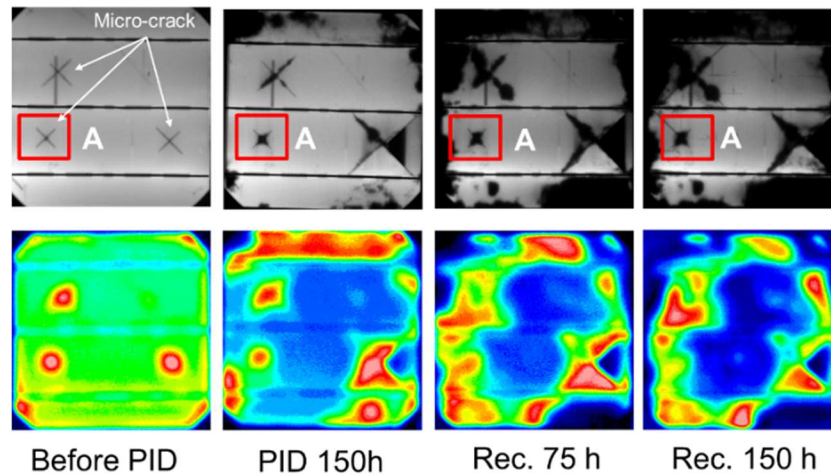
Figure 3. 5. EL (the top row) and LIT (the bottom row) images of large micro-cracked solar modules before and after PID stress and recovery processes.
